## Replacement of Lamp System for the Microtek 9800XL Scanmaker

### Lamp Replacement

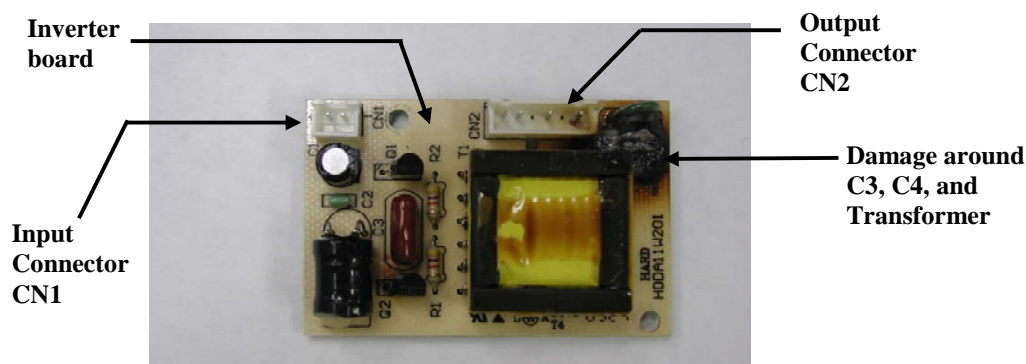
**Inverter Component Locations**

- **Checking the inverter for damage**
  - At this time check the inverter for damage. Typically if there is damage it will occur around the output capacitors C3 and C4 and the transformer T1 (See Photo of inverter component location). The corner of the printed circuit board can become burned and C3 or C4 can be destroyed. If this is the case consider replacement of the inverter with the BXA-2405LP-1 inverter from JKL Components Corporation before replacing the lamp assembly.
- **Inserting the new lamp assembly BF20325-24B/ASSY/01**
  - Each lamp of the lamp assembly will fit into the lamp rail. Center the lamp in each reflector and push the end caps down into the reflector. The wires can be bent so that the wires come out the ends of the rail.
  - Start by finding the small cutout on the side of the rail where the lamp wires from the old lamp assembly transitioned down to the inverter.

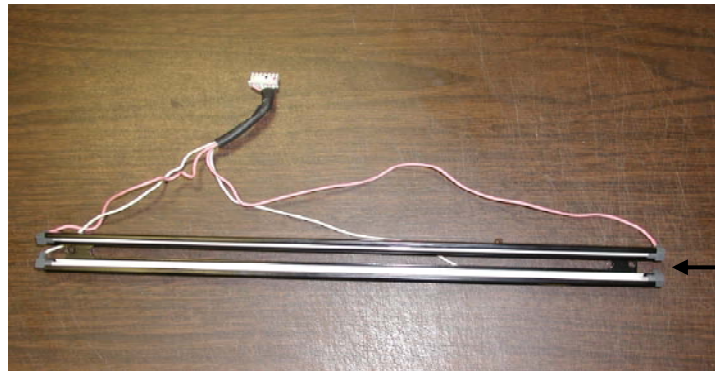
**Lamp Rail Assembly with Old Lamps**

Lamp End  
Caps

- **Removal of the old lamps**
  - Remove the Lamp Head Assembly from the Scanmaker body.
  - Remove the top plate from the scan head exposing the inverter circuit board.
  - Unplug the connector body from CN2 connector and thread the connector cable through the opening on the side of the scan head.
  - Lamp cable is threaded through a slot in the lamp reflector assembly. Un-thread the lamp cable from the slot.
  - Lamps can then be slid until one end cap is released from the lamp reflector assembly. The other end cap and lamp can then be lifted out from the reflector for each lamp.

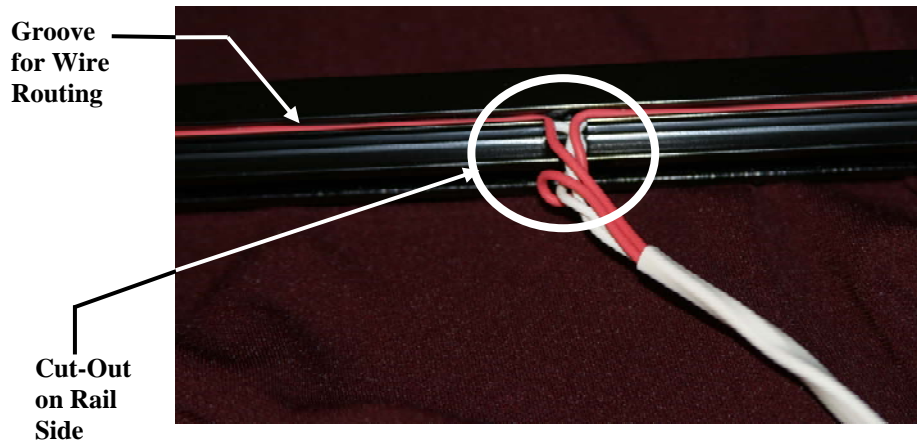
- Place the new lamp assembly so that the longer wires are away from the cutout and place the lamp with the red/pink wires furthest from the cutout.

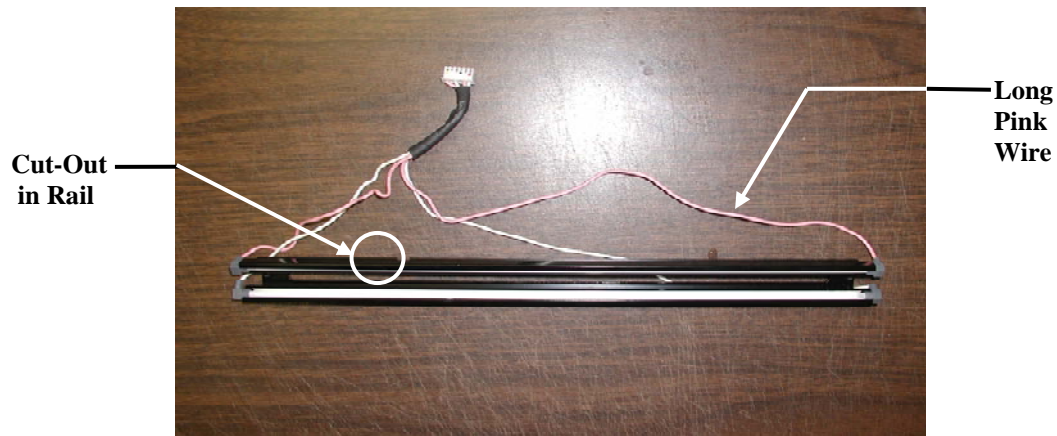
- Insert the lamp with the white wires into the reflector closest to the cutout. Run the wires out the ends of the reflector and press the wires into the groove underneath the reflector until the wires reach the cutout.
- Insert the lamp with the red/pink wires into the reflector furthest from the cutout. Run the wires out the ends of the reflector and across and under the other reflector. Place the wires in the same slot as the white wires and press in place.
- The lamp connector can then be threaded back through to the inverter and connected.
- Replace the cover and the assembly is completed. Replace the assembly in the scanner.

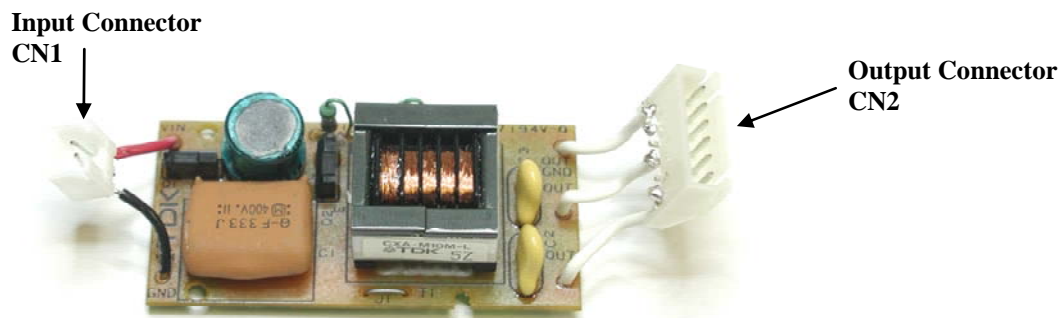
**BXA-2405LP-1 INVERTER**

- **Reconnecting the inverter (BXA-2405LP-1)**
  - Attach the input wire harness to CN1 and the output wire harness to CN2 and the inverter is connected. The connectors are keyed to mate in one orientation only do not try to force the connectors.

- **Inserting the new inverter (BXA-2405LP-1)**
  - The inverter has a set of sticky backed Velcro pads on the non-component side. The two pads can be separated and one pad can have the paper backing removed. The pad can then be placed on the flat surface of the lamp head.

- The inverter can be placed down onto the pad so that the two pads can come in contact. Note that the connectors should be in approximately the same location as with the old inverter.
